CLASSIFICATION		SECRET			25X 25X
COUNTRY	Czechoslovakia		REPORT NO.		
TOPIC	1. Pillbox Construction in Ruzomberok.				
	2. Security Detachments on the Zilina - Ruzomberok Railroad Line.				
25X1X EVALUATION		PLACE OBTAINED		25X1C	
25X1C DATE OF CONTENT					
DATE OBTAINED		DATE PREPARED	14 December 1953		
25X1A REFERENCES					
PAGES	3 ENCLOSURES (NO. & TYPE)				
REMARKS					
25X1X

Location Sketch of the Concrete Pillbox in Ruzomberok

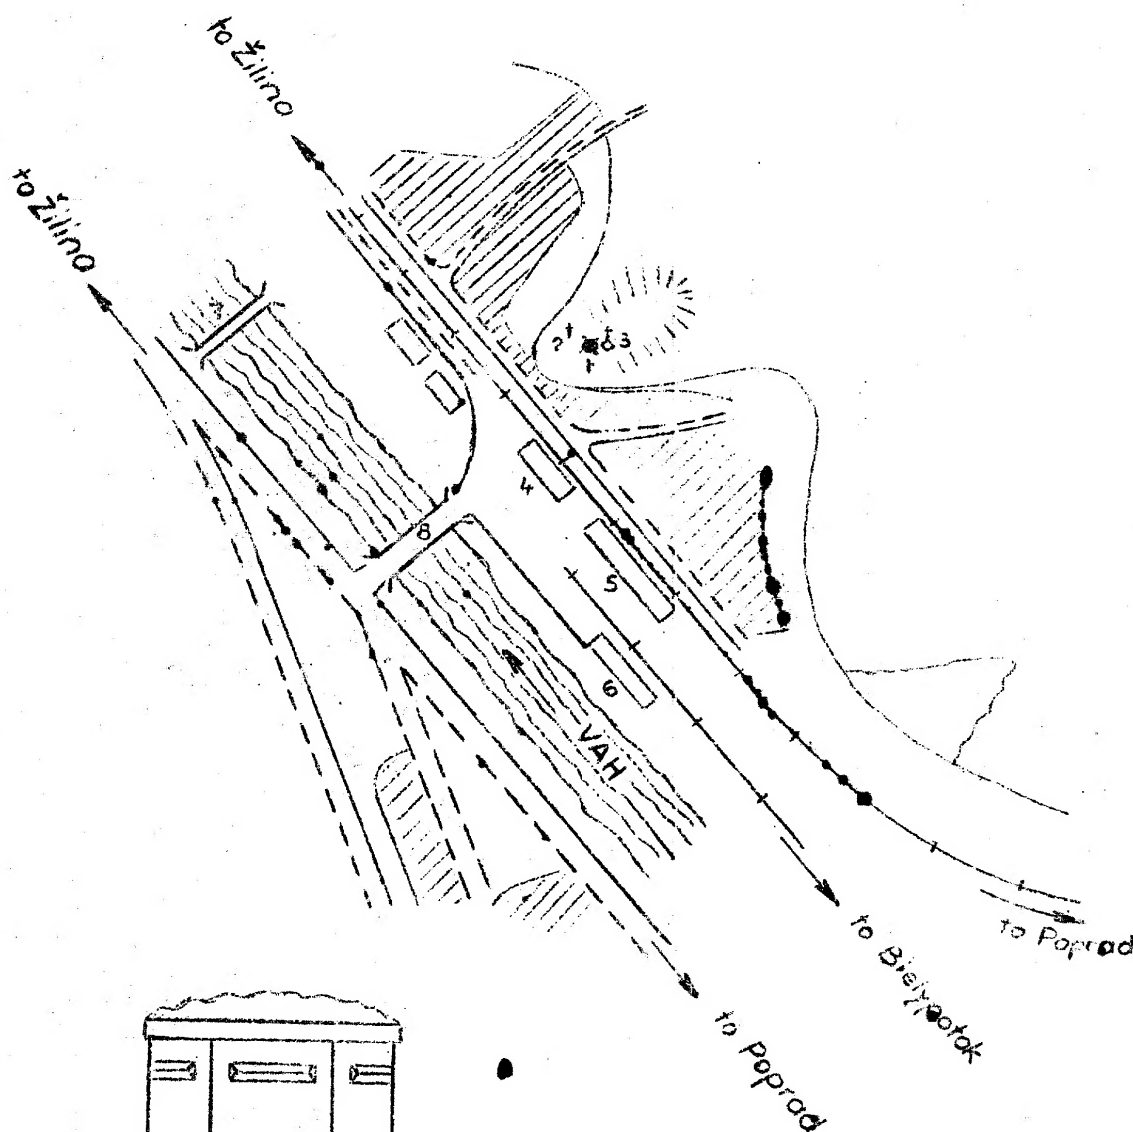
Location Sketch of the Concrete Pillbox in Ruzomberok.

- On 10 October 1953, an octagonal concrete pillbox was under construction on the Cavalry Hill northwest of the Ruzomberok (Q 50/C 99) railroad station close to the chapel. The hill commanded the town area of Ruzomberok, the railroad station, the bridges over the Vah River and a fairly long section of the Zilina (Q 50/O 92) - Kosice (R 49/E 34) double-track railroad line. The pillbox, which was worked on by two construction workers, projected about 1.5 meters from the ground and had a flat roof covered with an earth layer. Each of the visible side walls had a loophole, about 70 cm wide and about 25 cm high, which was about 30 cm beneath the roof.

- 1 Pillbox
  - 2 Cross
  - 3 Chapel
  - 4 Railroad Station
  - 5 Railroad depot
  - 6 Railroad depot
  - 7 Wooden bridge - closed
  - 8 Wooden bridge
- A Projection and horizontal plan of pillbox.
